Understanding and Mitigating

PMMA Bubbling

David Barth **UPenn** QNF, Singh Center 2023/09/14

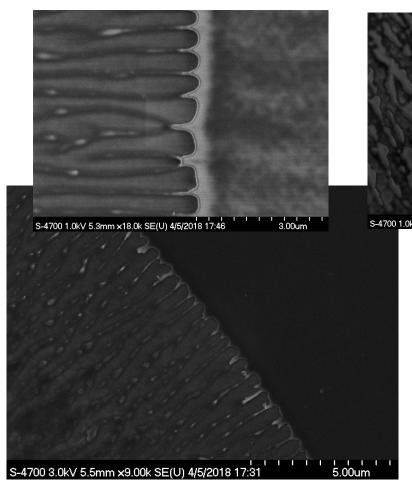
What does it look like?

Ti/Pt

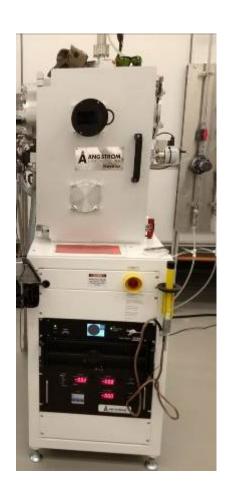
Angstrom NexDep (~2016)

- Open-load system
- 6 pocket hearth
- 7 cc liners
- ~20 cm throw
- Single shutter at sample
- Water cooled platen
- Bubbling issue was severe for Au, Pt, Pd

- Vendor was convinced it was thermal issue
- Z stage installed to allow longer throw
 - This actually made it worse
- I demonstrated that PMMA was fully exposed even with shutter closed for entire recipe
- Fabricated cylindrical shield to protect sample when shutter was closed
 - This solved problem except in extreme cases

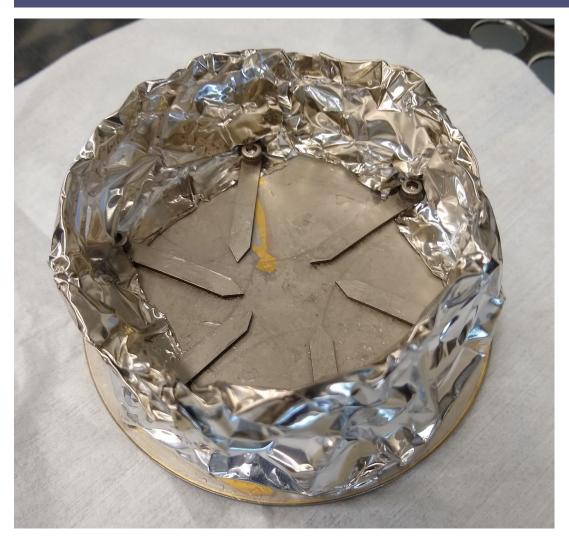
This solution works on other systems

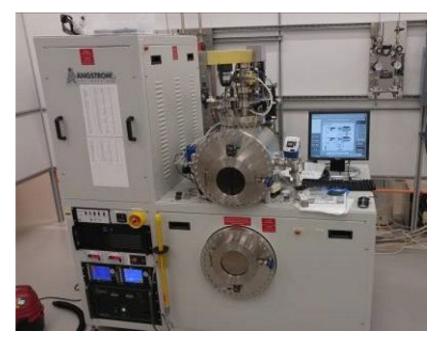
Custom Angstrom System

- Dual chamber design
- 6 pocket hearth, 15cc
- ~30 cm throw
- Single shutter at source + gate valve
- Resolution:
 - Confirmed that damage occurred before shutter open
 - Modified recipe to leave gate valve closed until immediately before shutter opened
 - Fully resolved problem
