Understanding and Mitigating

PMMA Bubbling

David Barth **UPenn** QNF, Singh Center 2023/09/14

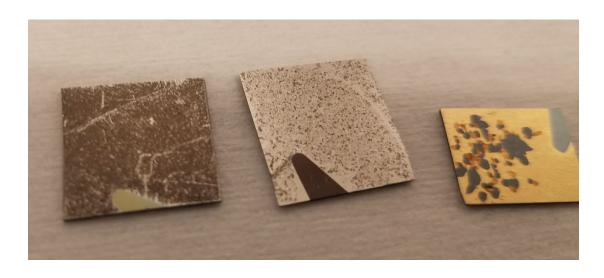
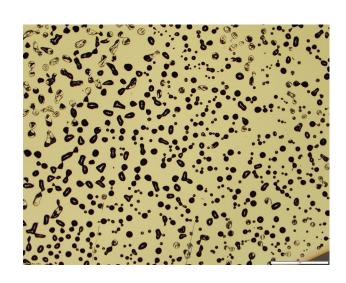
- Bubbling happens when volatile byproducts of chain scission are trapped between PMMA and a thin film
- Usually during e-beam evaporation
- Can also be an issue during EBL (especially alignment) if sample is coated for charge dissipation

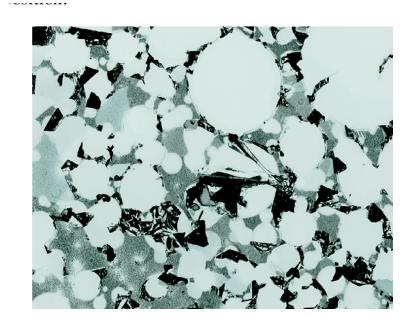
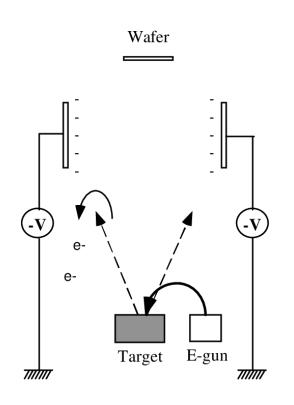
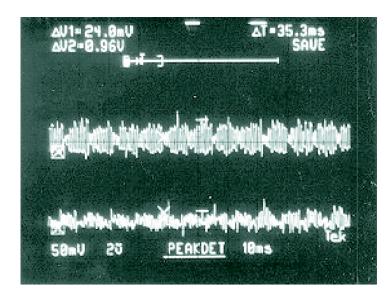
- Heat
- Bremsstrahlung x-rays
- Expired/contaminated resist
- Developers
- EBL hardware problems
- Magic
- Anything except charged particle irradiation!

Figure 2. Free electron signal (i.e., current) generated inside the chamber during platinum evaporation
